EXHIBIT 2

APPENDIX A

Comparison of Defective AirPods Sample #12 and Defective AirPods Sample # 20

Comparison of Defective AirPods Sample #10, #14, #25, and #32 (Comparison of Post-recall MEMS Microphones)

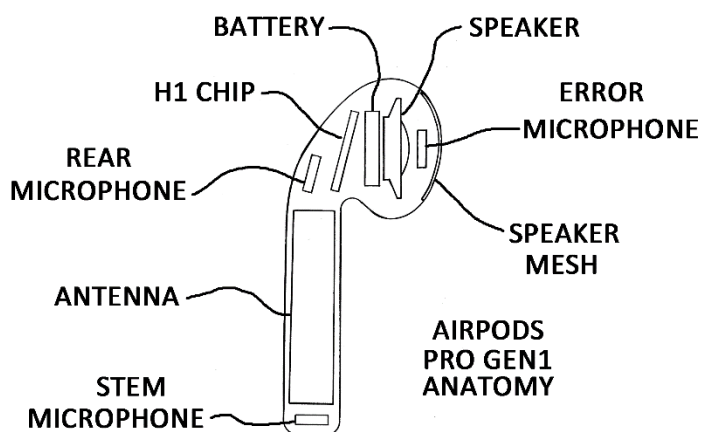
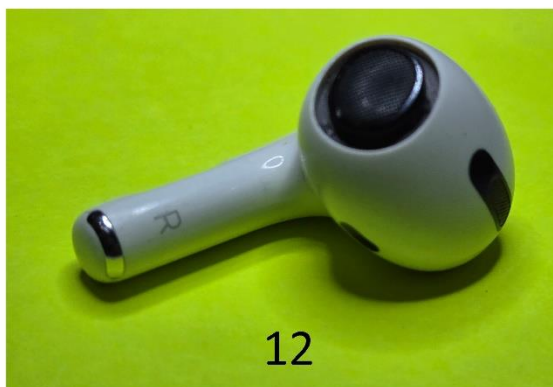
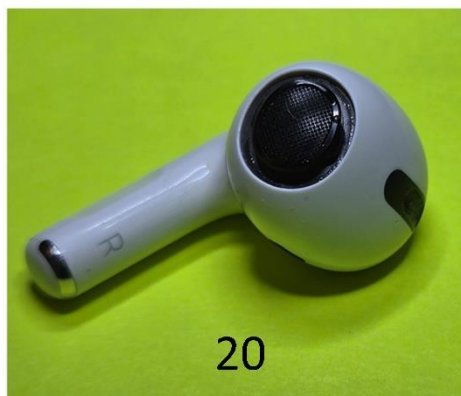
Perspective Views

Defective sample #12 was sold on 12/29/2019 approximately 9 months prior to the Pro Gen 1 recall cutoff date per Apple's records. Defective sample #20 was sold on 3/3/2021 approximately 6 months after the Pro Gen 1 recall cutoff date per Apple's records. Fifteen (15) months separated the two sales dates which straddled the October 1, 2020 recall cutoff date.

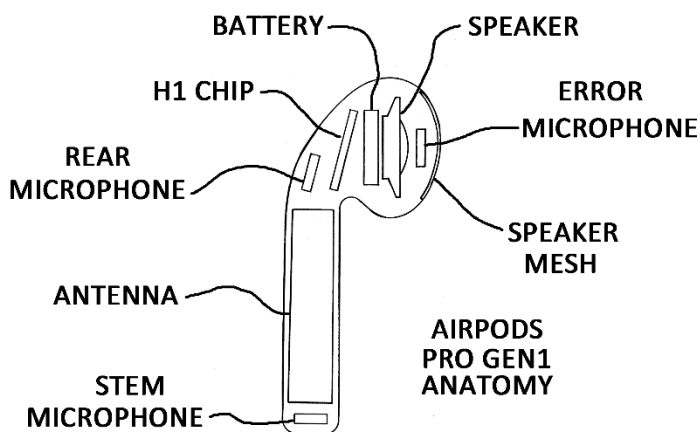
The diagram below shows the relative location of the three MEMS microphones in the Pro Gen 1 AirPods.

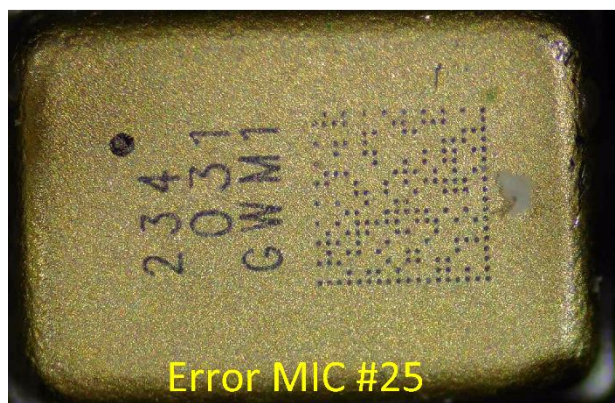
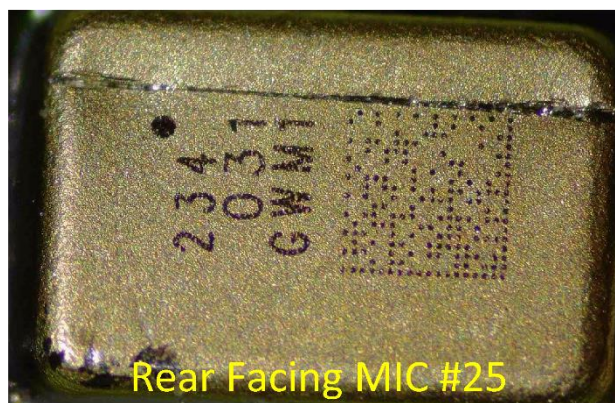
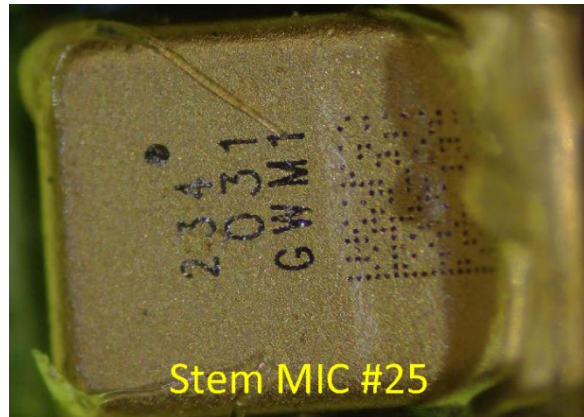
Defective sample #25 was sold on 10/27/2020 approximately one month after the Pro Gen 1 recall cutoff date per Apple's records. The eBay seller of this sample complained of "static in both earpods". These AirPods were tested 4/9/2024 by Apple (Apple Carnegie Library) using Apple's proprietary test apparatus and protocol. The Apple test report corroborated the user's complaint explaining:

Ran audio-failed- both failed with static and crackling present, failed audio frequency on both.

The following MEMS microphones were utilized in Pro Gen 1 Airpod sample #25 which was sold one month post-recall. The Goertek model GWM1 was used for all three microphone applications.

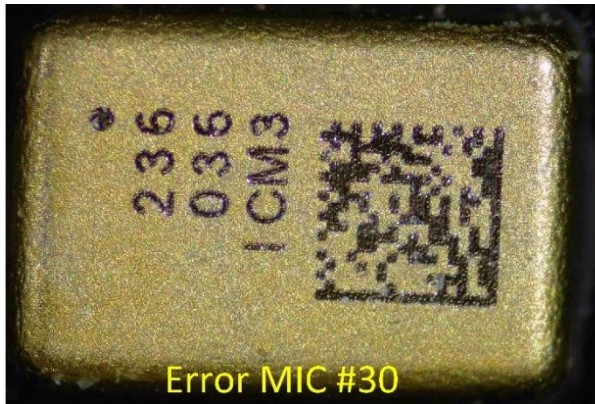
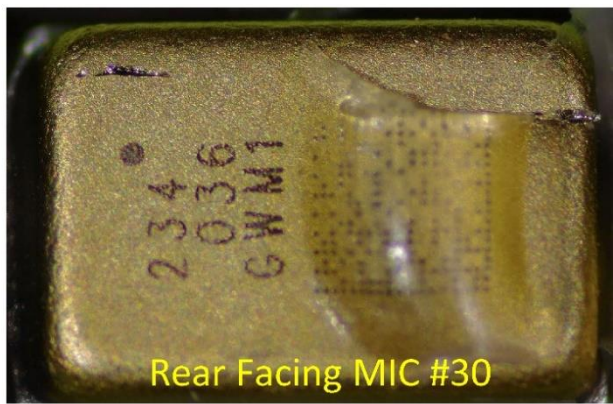
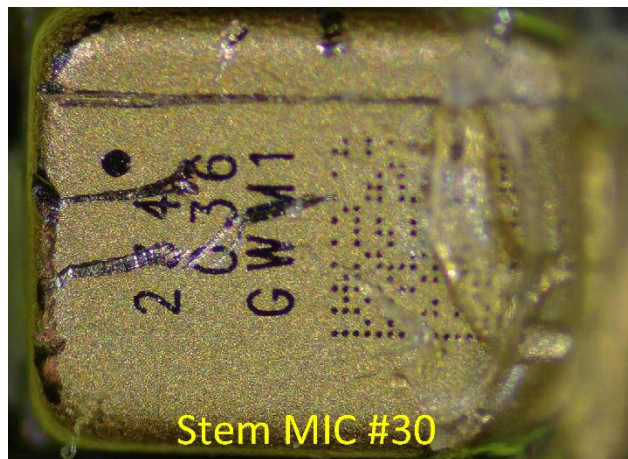
Defective sample #30 was sold on 12/11/2020 approximately 3 months after the Pro Gen 1 recall cutoff date per Apple's records. The eBay seller of this sample complained "there is static". These AirPods were tested 4/9/2024 by Apple (Apple Clarendon) using Apple's proprietary test apparatus and protocol. The Apple test report corroborated the user's complaint explaining:

Steps to Reproduce: Verified issue via Audio diagnostics.

The following MEMS microphones were utilized in Pro Gen 1 AirPods sample #30 which was sold three months post-recall. The Goertek model GWM1 was not used for the Error Microphone application. There appears to be no public information on the model ICM3 error microphone.

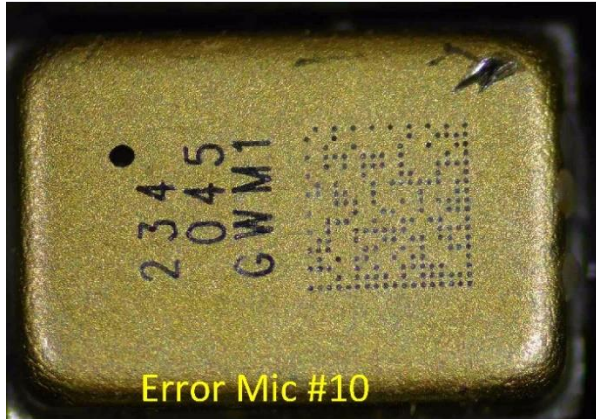
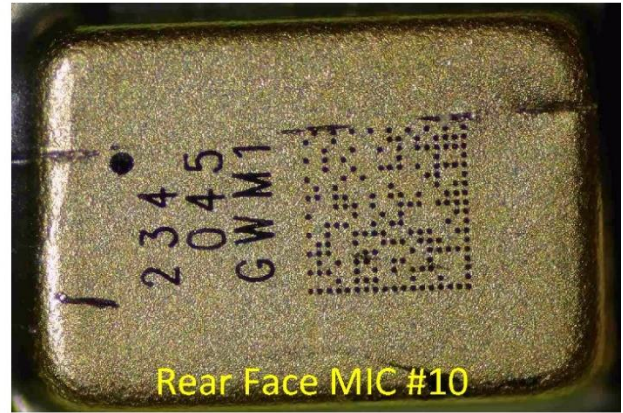
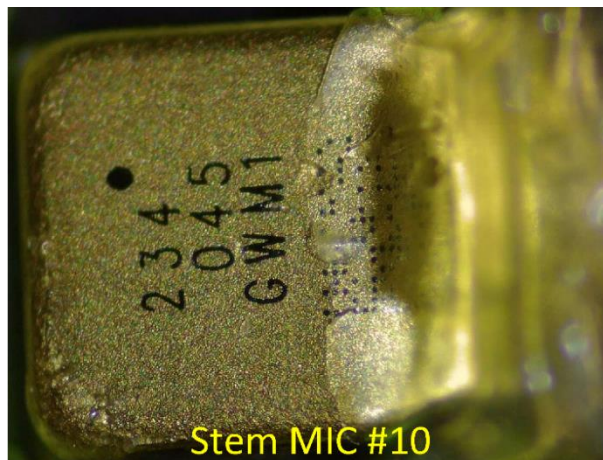
Defective sample #10 was sold on 3/29/2021 approximately 6 months after the Pro Gen 1 recall cutoff date per Apple's records. The eBay seller of this sample complained of "hum and noise". These AirPods were taken to an Apple Store on 4/28/2024 (Apple Eton). There appears to be no result of Apple's audio testing in the record.

The following MEMs microphones were utilized in Pro Gen 1 AirPods sample #10 which was sold six months post-recall. The Goertek model GWM1 was used for all three microphone applications.

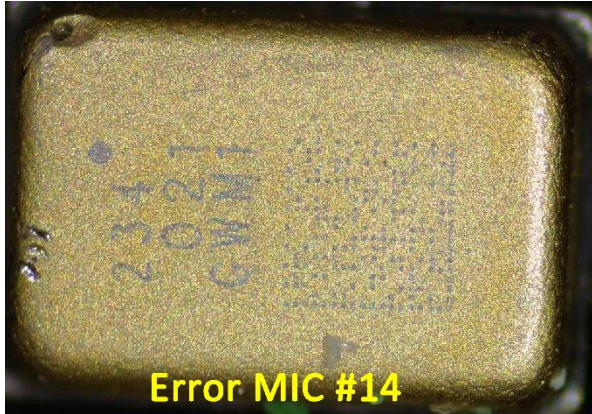
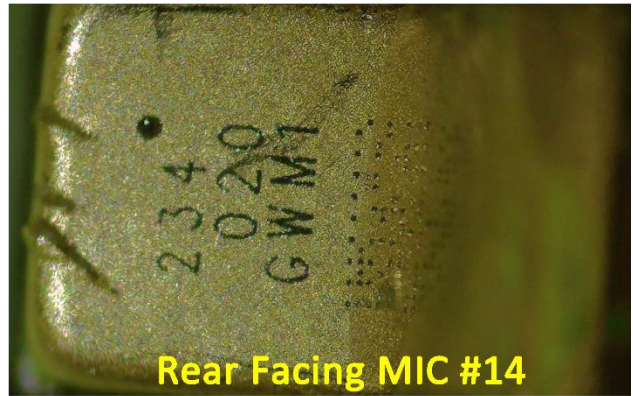
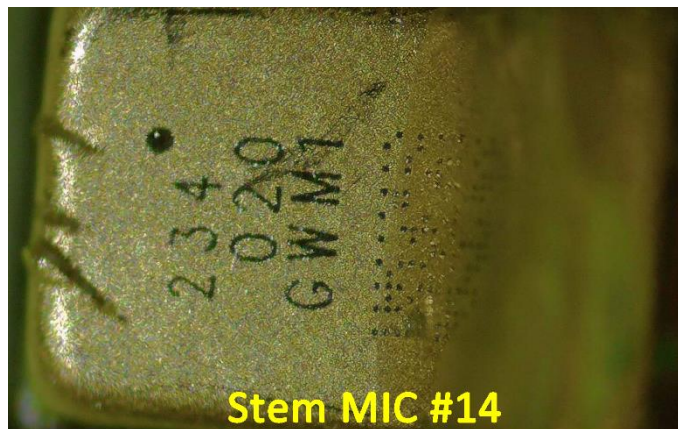
Defective sample #14 was sold on 2/4/2022 approximately 17 months after the Pro Gen 1 recall cutoff date per Apple's records. The eBay seller of this sample complained of "right earbud crackling". These AirPods were taken to an Apple Store on 5/7/2024 (Apple Crocker Park).

The following MEMs microphones were utilized in Pro Gen 1 AirPods sample #14 which was sold 17 months post-recall. The Goertek model GWM1 microphone was used for all three microphone applications.

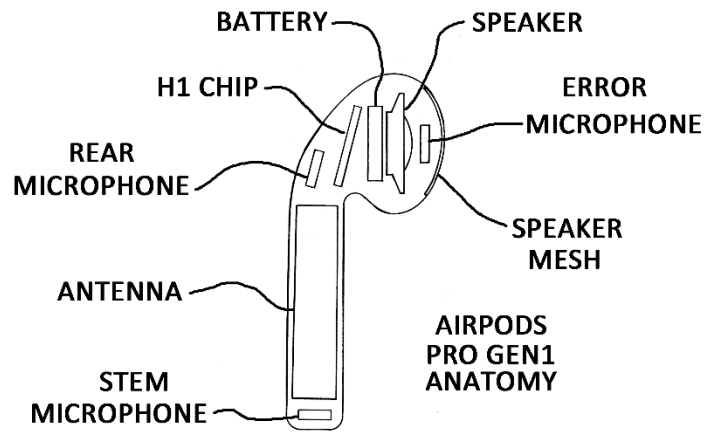
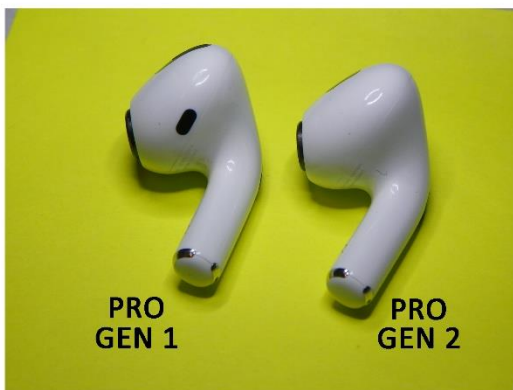
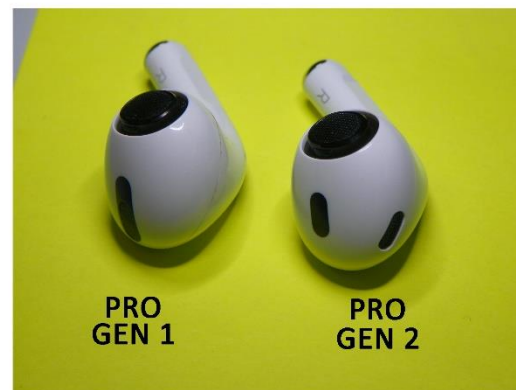
Defective AirPods Pro Gen 1 sample #14 was sold on 2/4/2022 approximately 16 months after the Pro Gen 1 recall cutoff date of October 1, 2020 per Apple's records. New Pro Gen 2 AirPods were purchased on June 21, 2024 (Amazon) after having been introduced by Apple on 9/23/2022.
